WEAR MECHANISMS OF VALVES AND VALVE SEAT INSERTS IN A GAS-FIRED RECIPROCATING ENGINE

**P. I. Lacey
S. M. Hsu
R. S. Gates
S. Lee
L. Ives
C. Ku
P. Pei
Y. Wang
E. P. Whinton
R. G. Munro**

June 1990

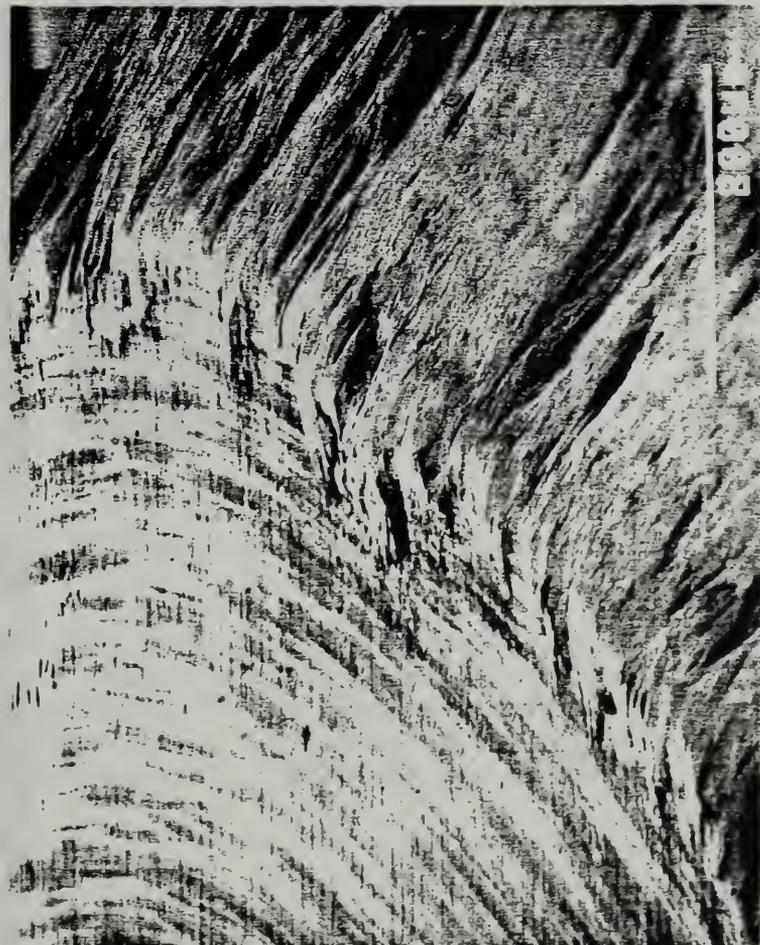
Fig. 7

TRIBALLOY-800 INTAKE VALVE
(vs. SIALON)

overspeed which prematurely concluded the engine test contributed in a significant way to generating the damage. Similar features are visible on the Triballoy 800 inlet valve shown in Fig. 7. In contrast the Triballoy 800 exhaust valve shown in Fig. 8 has a relatively smooth and unworn surface by comparison. Note the layer of deposit which is clearly visible on the valve face.

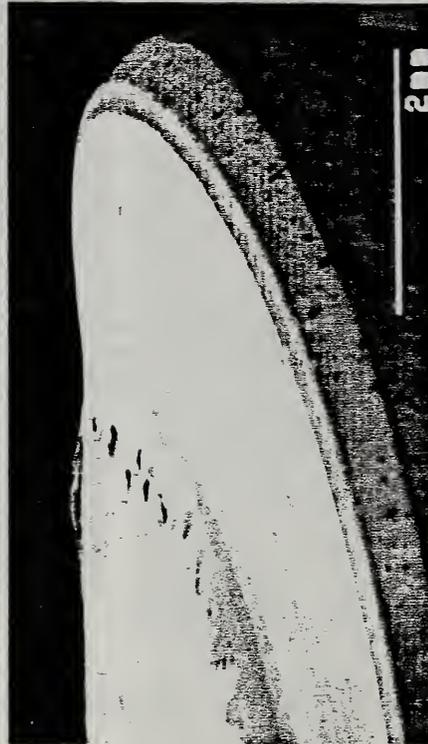
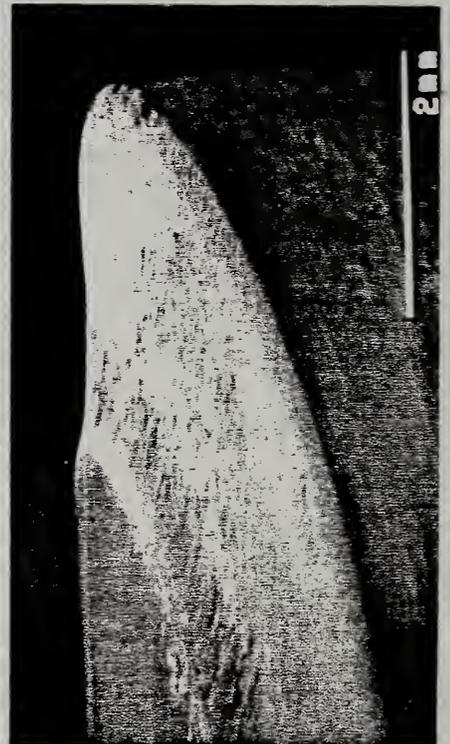
Fig. 10

TRIBALLOY 800
(vs. SiALON)

Photographs of the worn surfaces from each of the valves are shown in Figs 10 and 11 for comparison. All of the Stellite 6 and Tribaloy 800 valves coupled with ceramic seat inserts are smooth and free of pitting, although gross plastic flow has taken place towards the inside of the seat on the intake valves. The surface of the Stellite 1 valve is rough by comparison, probably because the Eatonite counterface is relatively soft compared to ceramic, hence compliance is not confined to the valve face.

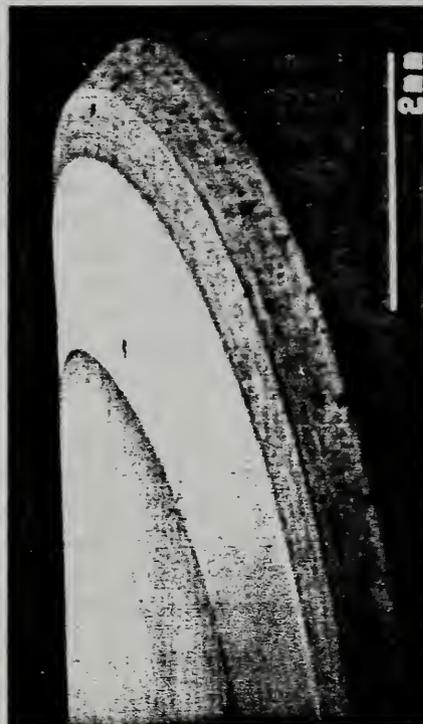
TROBALOY-800
(vs. AY-6Si₃N₄)
